**TEST REPORT nr. S11116301**

Description.....: BUSWAY  
 Trademark .....: POGLIANO BUSBAR  
 Model/Type.....: 1. 235100S1LPA  
 2. 234600S1LPA

Standard.....: EN 60529:1991 + A1:2000

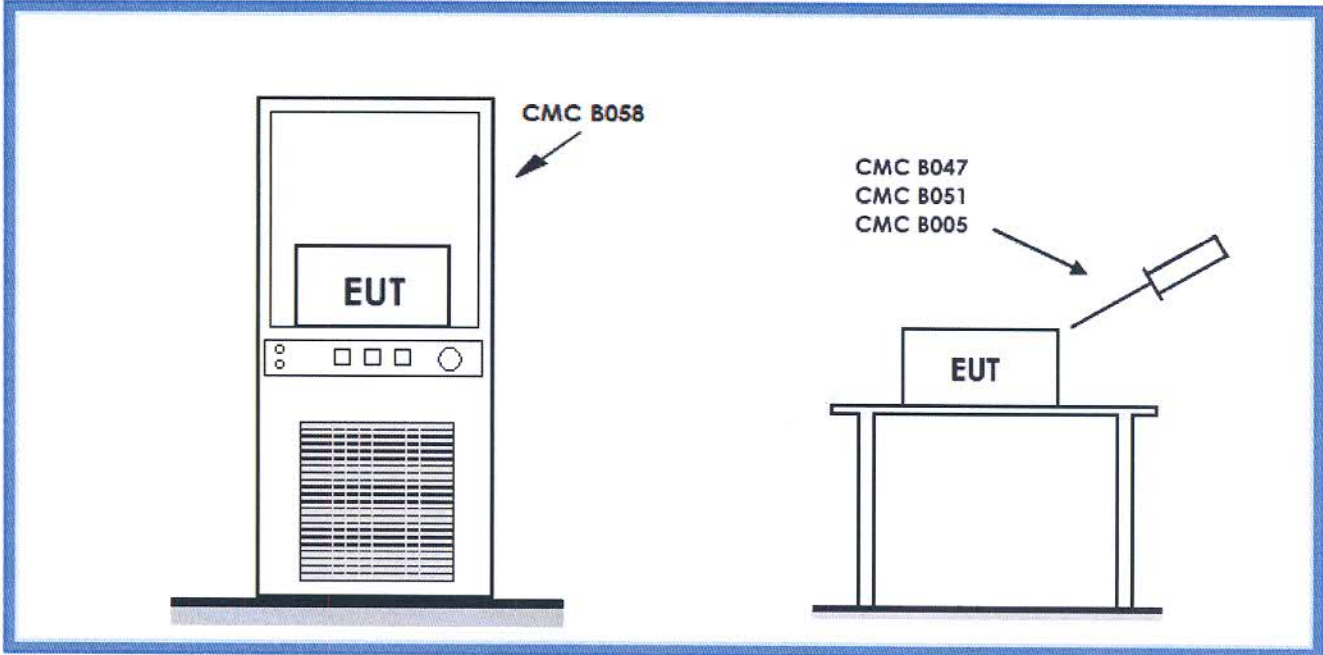
**Setup**

First Characteristic Numeral	Additional Letter	Result
IP6X	--	P
<b>Remarks:</b> No dust inside the enclosure. Test executed on model 235100S1LPA

First Characteristic Numeral	Additional Letter	Result
IP6X	--	P
<b>Remarks:</b> No dust inside the enclosure. Test executed on model 234600S1LPA

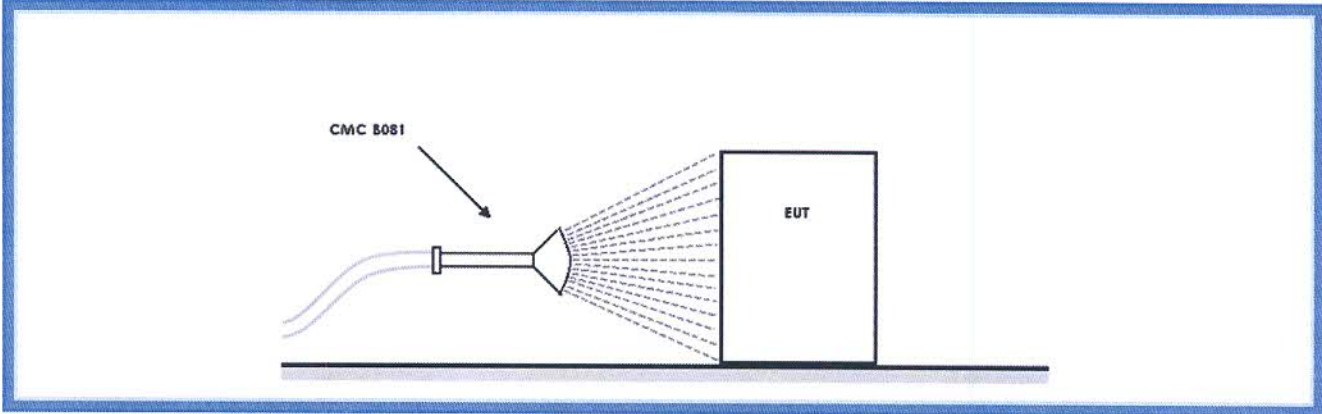
**Setup**

Second Characteristic Numeral	Supplementary Letter	Result
IPX5	--	P
<b>Remarks:</b> No water inside the enclosure. Test executed on model 235100S1LPA

Second Characteristic Numeral	Supplementary Letter	Result
IPX5	--	P
<b>Remarks:</b> No water inside the enclosure. Test executed on model 234600S1LPA
